Manhole Inspection Summary

Manhole # S31K__027MH

Printed On: 4/3/2009

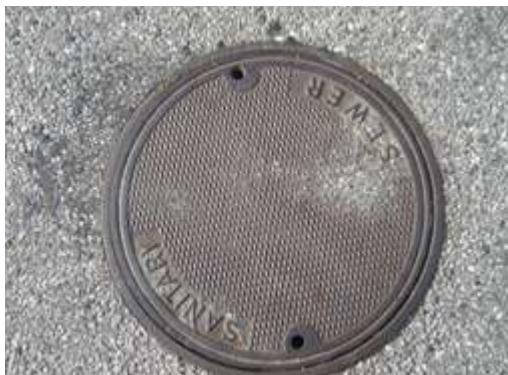
Misc

cover

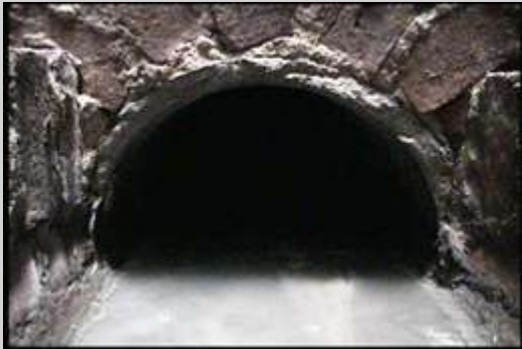
12 O'Clock Outflow

Pipe Height: **9.6** (in.) Rod and Bar (Angled)
Pipe Material: **Clay** ☐ Pipe Lined
Invert Depth: **15.04** (ft.) Flow Characteristics: **Fast**
Deposits: ☒ None ☐ Mud ☐ Sludge ☐ Debris ☐ Grease
Silt Depth: **0** (in.) Deposits Extent:
Infiltration: **None** Pipe Seal Cond: **Sound**

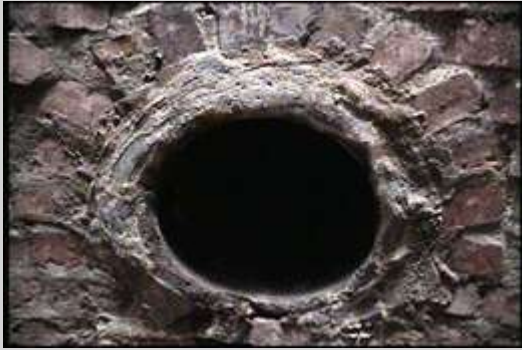
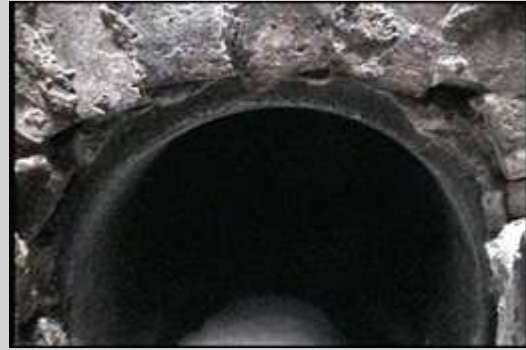
9 O'Clock Inflow

Pipe Height: **10.8** (in.) Rod and Bar (Angled)

Infiltration: **None** Pipe Seal Cond: **Sound**

Drop Condition: **Open**
